DOT/FAA/CT-94/56

# Characterization of Corrosion and Development of a Breadboard Model of a D Sight Aircraft Inspection System: Phase I

August 1994

Final Report

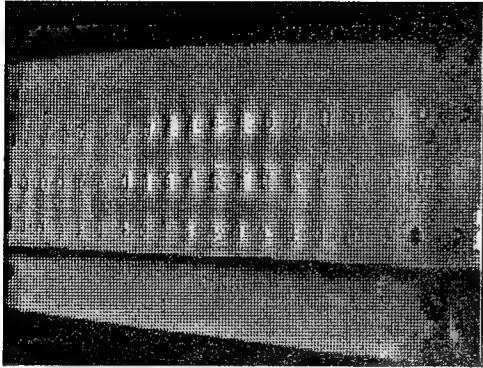
FIGURE 1.- D SIGHT IMAGE OF CORRODED LAP SPLICE WITH DAIS-250C SENSOR (LEFT) AND CORRESPONDING EDDY CURRENT IMAGE (RIGHT)

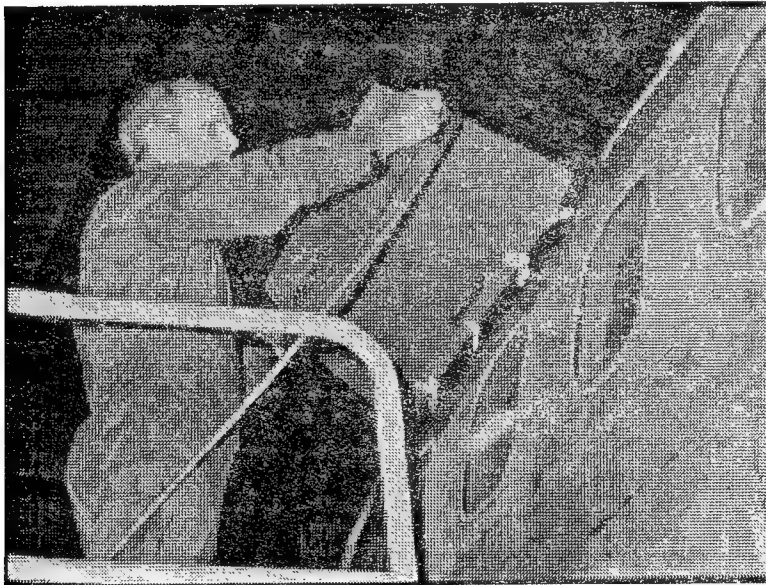
These field trips were extremely valuable in determining inspection procedures, inspection rates, and any shortcomings with the sensor or inspection equipment. Unfortunately, on-site confirmation of corrosion and detection sensitivity was not possible. The B-727 panel from Winnipeg, however, will be characterized fully at NRC and compared with the field inspections. Figure 2 shows the DAIS-250C being used to inspect the B-737 at the AANC.

FIGURE 2.- FIELD TRIAL OF DAIS-250C AT AANC, ALBUQUERQUE, NEW MEXICO

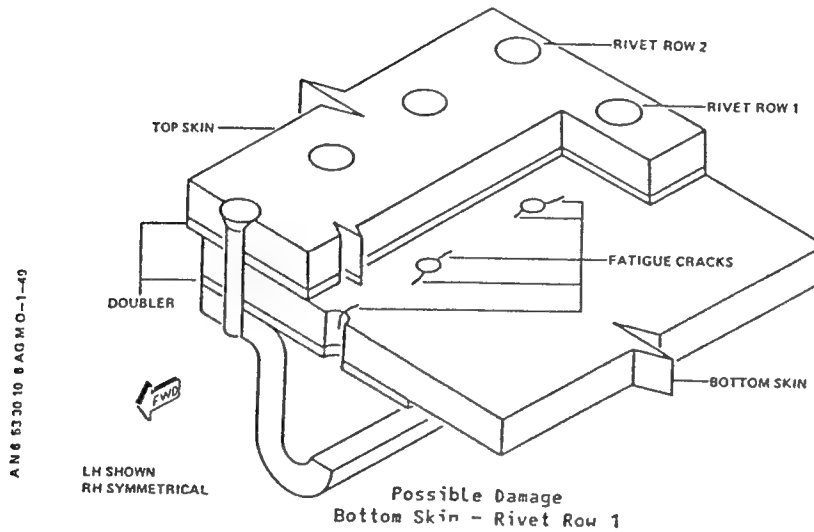
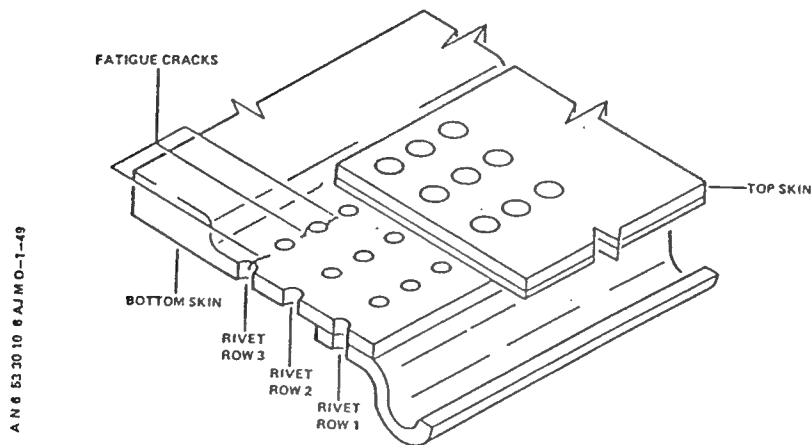
Possible Damage  
Bottom Skin - Rivet Row 3

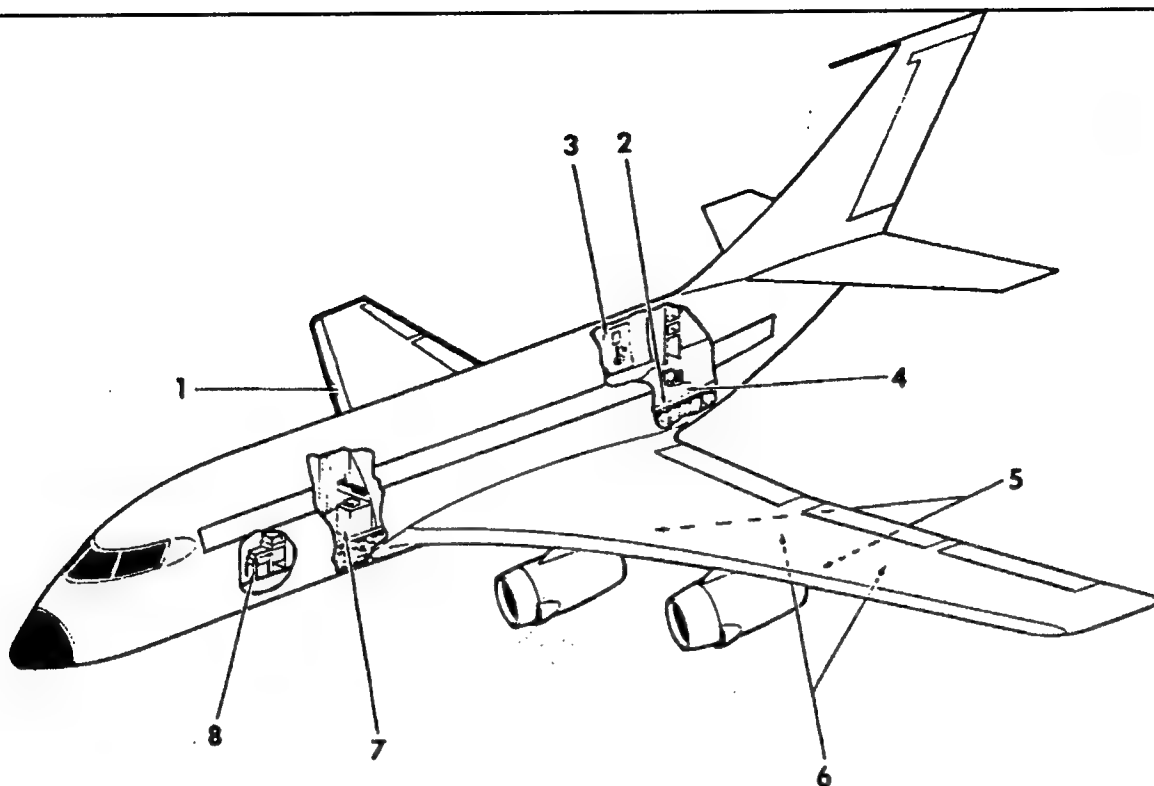
#### **1 UNDER DE-ICER BOOTS**

Moisture may collect under the boots and result in corrosion.

Figure 17. Areas most susceptible to corrosion [2]

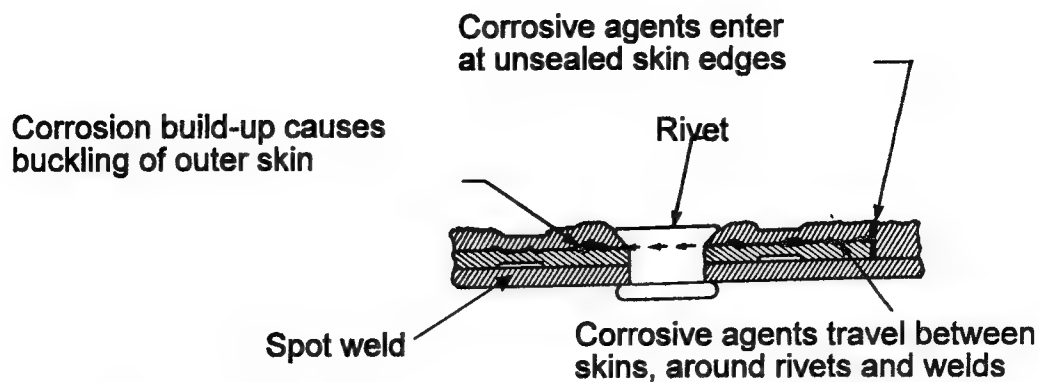
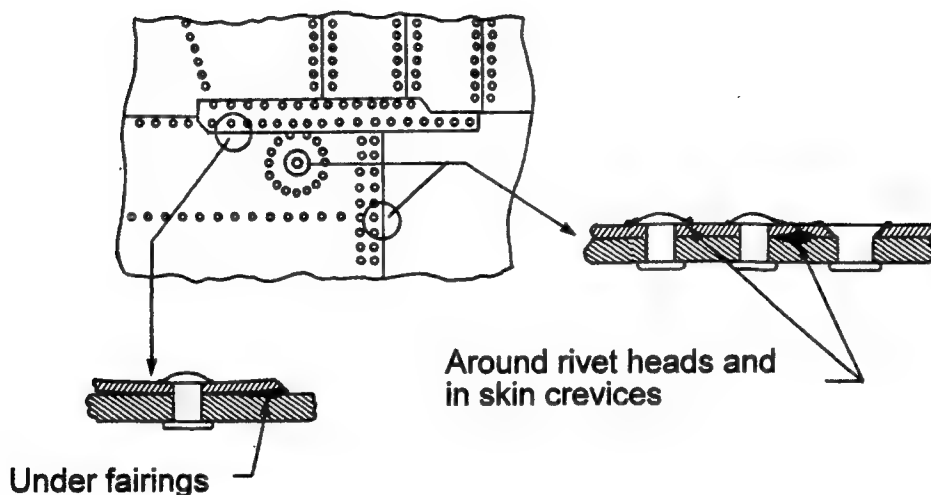
- Corrosion may be evident in spot-welded skins by corrosion products appearing at the crevices through which the corrosive agents entered and is usually more prevalent on external areas (Fig. 18);
- Piano-type hinges are also prime sites for corrosion as are edges of honeycomb panels and drilled holes;
- Lower fuselage, wing and flap areas aft of wheels suffer damage in protective coatings due to impact from particles thrown up from the runway on takeoff and landing;
- Canopy and passenger/crew/cargo door structures and associated hinges, fittings, and mechanisms may be damaged due to the combined effects of mechanical and corrosive action;
- Windows and door frames may be similarly affected." [2]

### SPOT-WELDED SKIN CORROSION POINTS

### EXHAUST TRAIL AREA CORROSION POINTS

Figure 18. Corrosion prone areas.

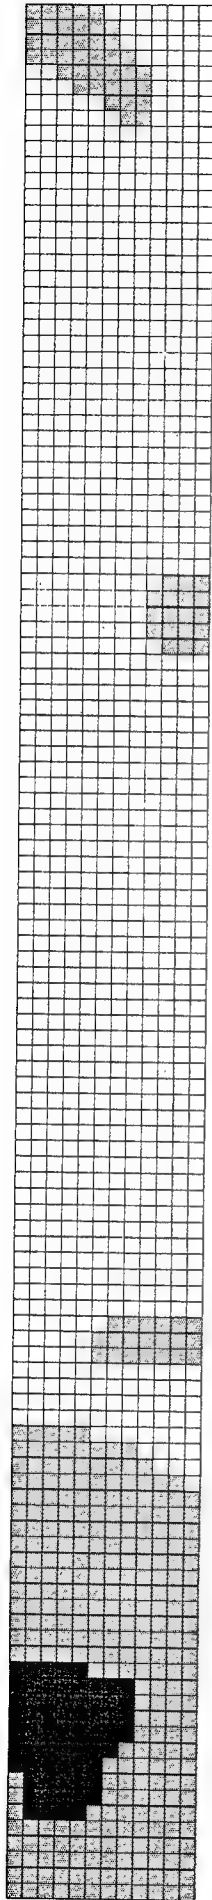
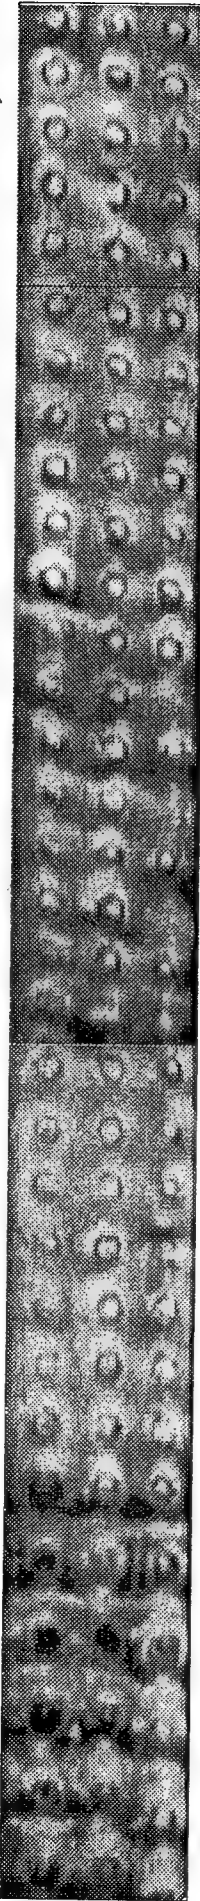
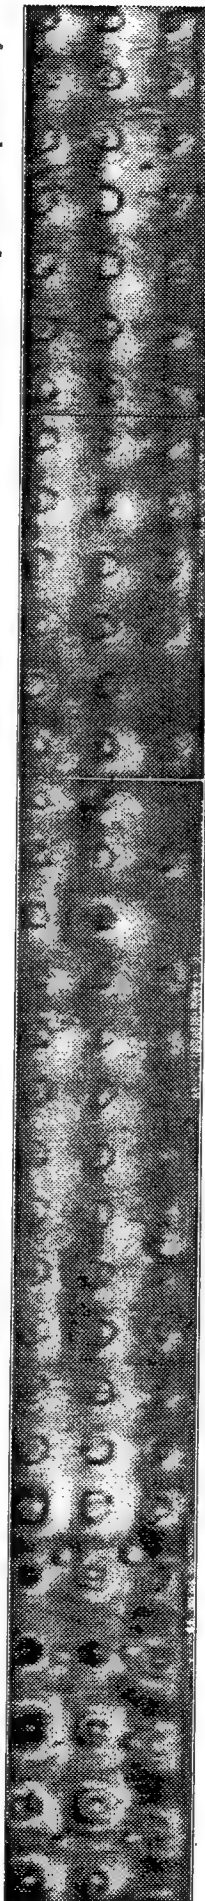
Fig. 1 Area #1, Stringer 18, BHS 1100

Location and Severity Classifications determined by Diffractometry

D SIGHT mosaic image with sensor positioned parallel to joint

D SIGHT mosaic image with sensor positioned perpendicular to joint

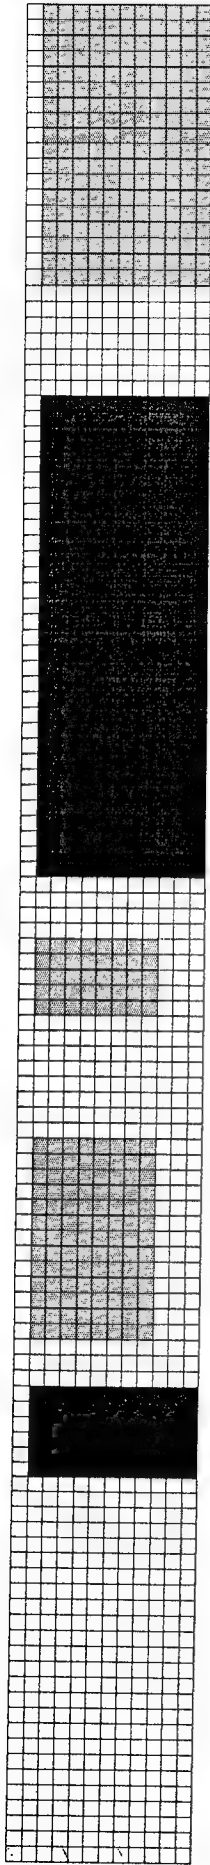
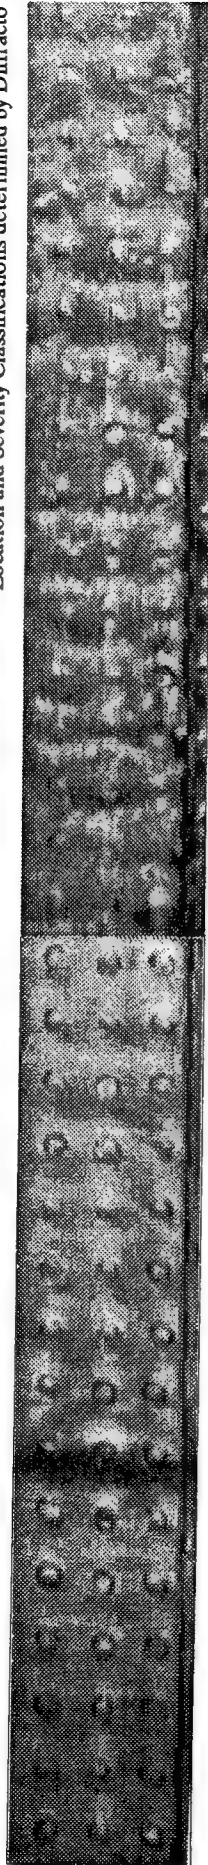
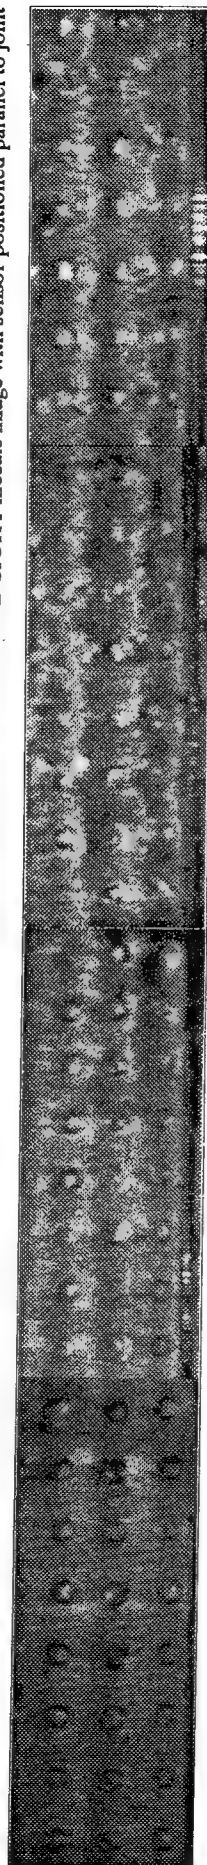
Fig. 2 Area #2, Stringer 14, BHS 1000

Location and Severity Classifications determined by Diffracto

D SIGHT mosaic image with sensor positioned parallel to joint

D SIGHT mosaic image with sensor positioned perpendicular to joint

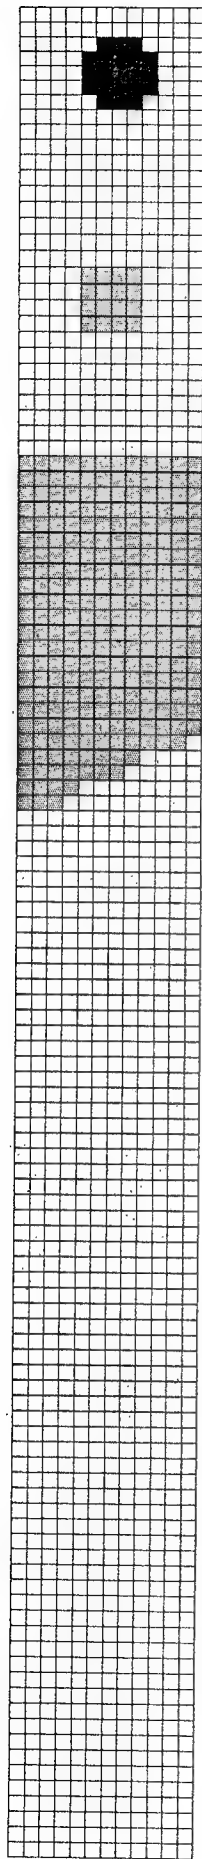
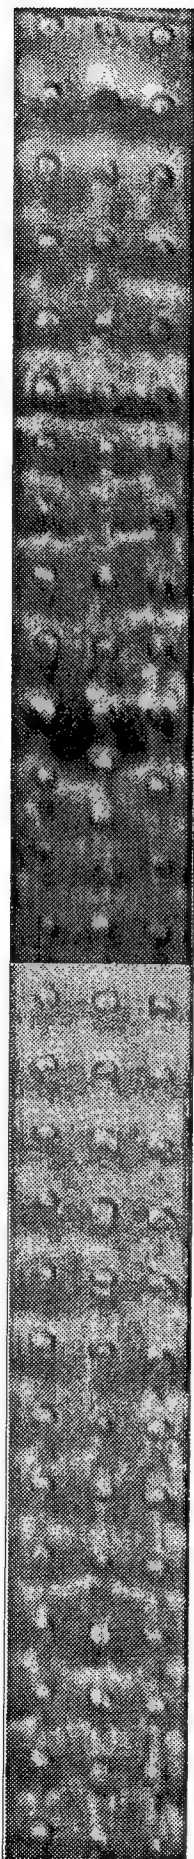
Fig. 3 Area #3, Stringer 7, BHS 1020

Location and Severity Classifications determined by Diffracto

D SIGHT mosaic image with sensor positioned parallel to joint

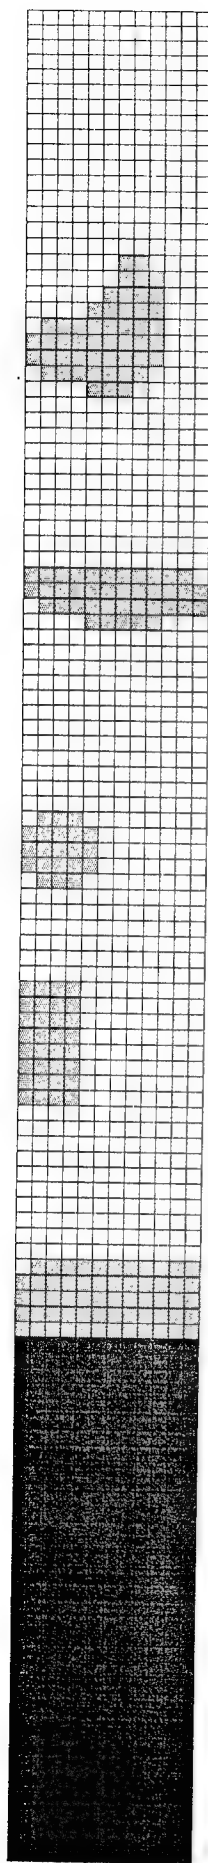
Fig. 4 Area #4, Stringer 14, BHS 640

Location and Severity Classifications determined by Diffractometry

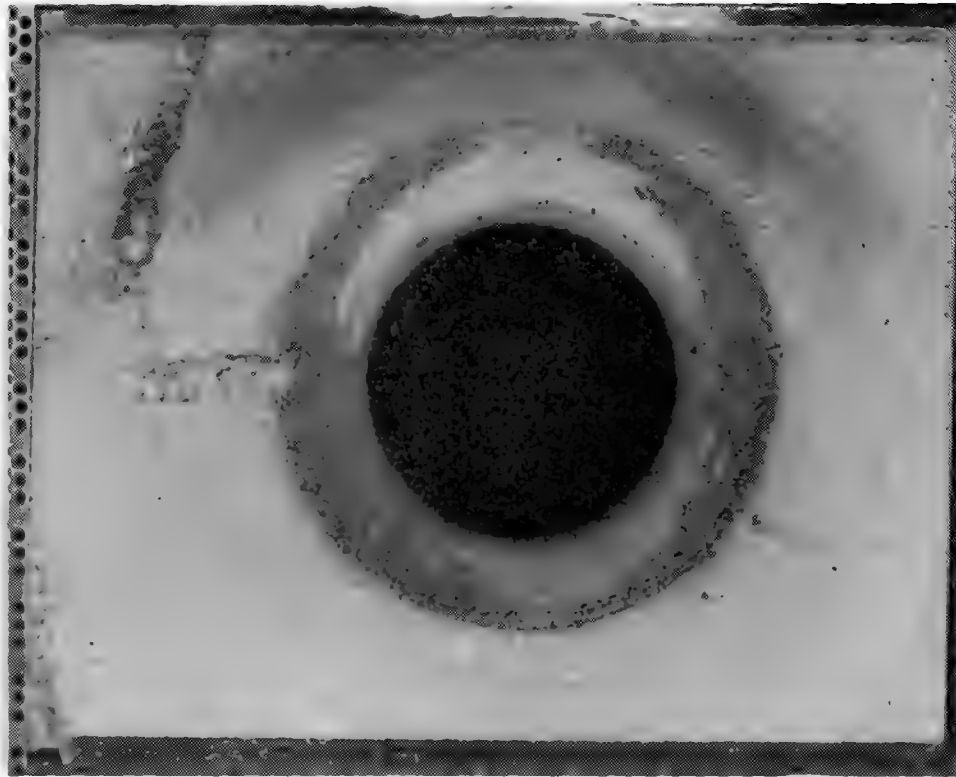
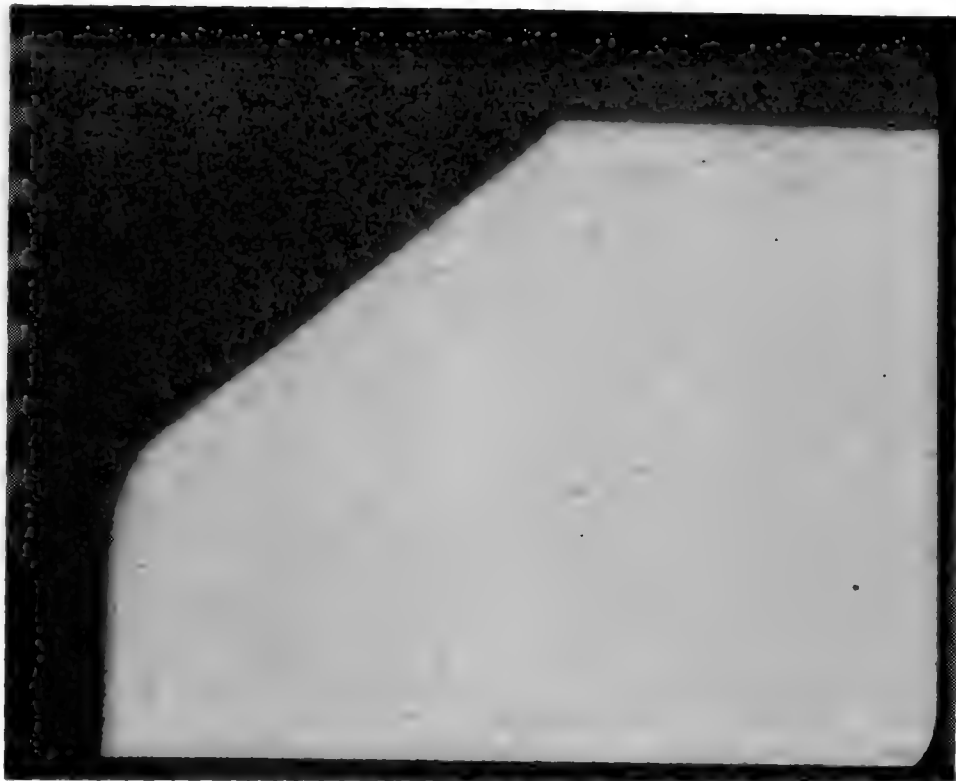
TYPICAL FASTENER HOLE CONDITIONS

COUNTERSINK SURFACE 50X

GOOD COUNTERSINK CROSS SECTION 50X

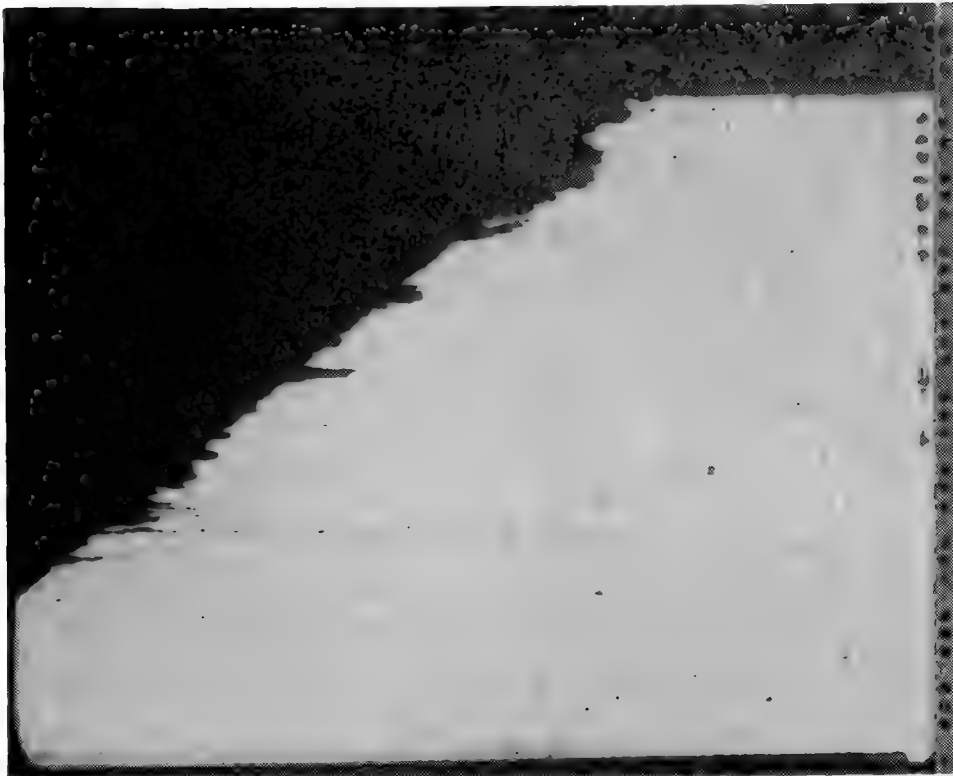
CROSS SECTION SHOWING PITTING AND EXFOLIATION 50X

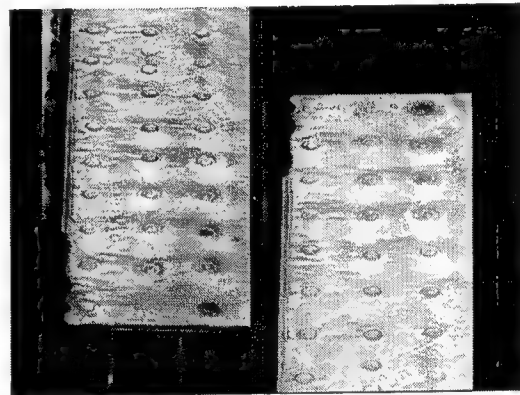
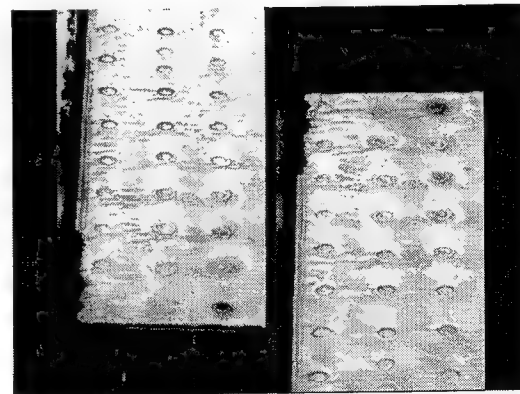
**Figure 2:** Opposing views of sample with lamp below lens

**Figure 3:** Opposing views of sample, lamp above lens

the lamp above and below the lens. In both cases the lamp is positioned as closely as possible to the lens without entering its field of view. Figure 2 shows opposing views of the rivets with the lamp below the lens while the lamp is above the lens in Figure 3. To aid in comparing the opposing views of the same part, the right view has been mirrored so that same rivet row is on the left side in both images. By using a beamsplitter the lamp can be made coincident with the optical axis of the lens. Due to the significant power losses through beamsplitter the lamp must be run at full voltage. Figure 4 illustrates an image of the surface illuminated in this manner.

When the decision was made to mount the lens above the lamp in the DAIS 500, it was assumed that its only effect on the resulting images would be to invert the "polarity" of the waviness signatures. However, as can be seen in Figures 7 and 8, locating the lamp beneath the lens causes a visible increase in the contrast of the surface signatures. This is likely due to the small but significant reduction in the lamp's grazing angle. The entire issue of whether the lamp should be above or below the lens or whether the signatures are too asymmetric to be readily interpretable could be resolved by mounting the lamp on-axis with the lens, see Figure 4. However this produced very subtle signatures with a serious loss of illumination power. Mounting the lamp off-axis, below the lens produced images of sample 4743R1 with the best signal to noise ratios.

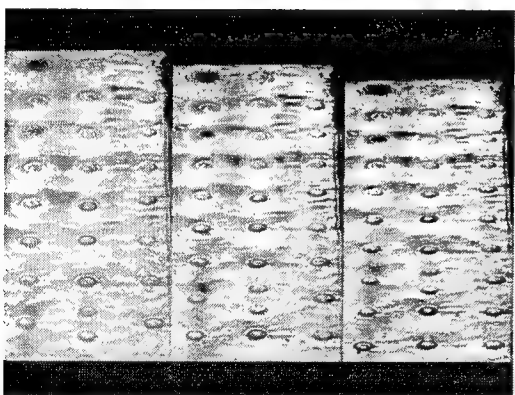
Figure 5: Imaging corroded rivets at 32, 27 and 22.5 deg. grazing angle

Figure 5 illustrates three views of the rivets taken with the 1.4 in. reflector lamp below the lens and the camera grazing angle set to 32 deg., 27 deg. and 22.5 deg. Using a camera grazing angle of 22.5 deg. Figure 6 shows four views of the two worst rivet rows with the retroreflective screen located 6 in., 12 in., 18 in. and 24 in. from the centre of the surface. With the screen to surface distance set to 18 in. the effect of lamp size was tested next. In Figure 7 two images of the same surface region are shown with the lamp 1.4 in. diameter reflector lamp located above and below the lens. The views in Figure 8 are similar except that the lamp now has a 2 in. diameter reflector.

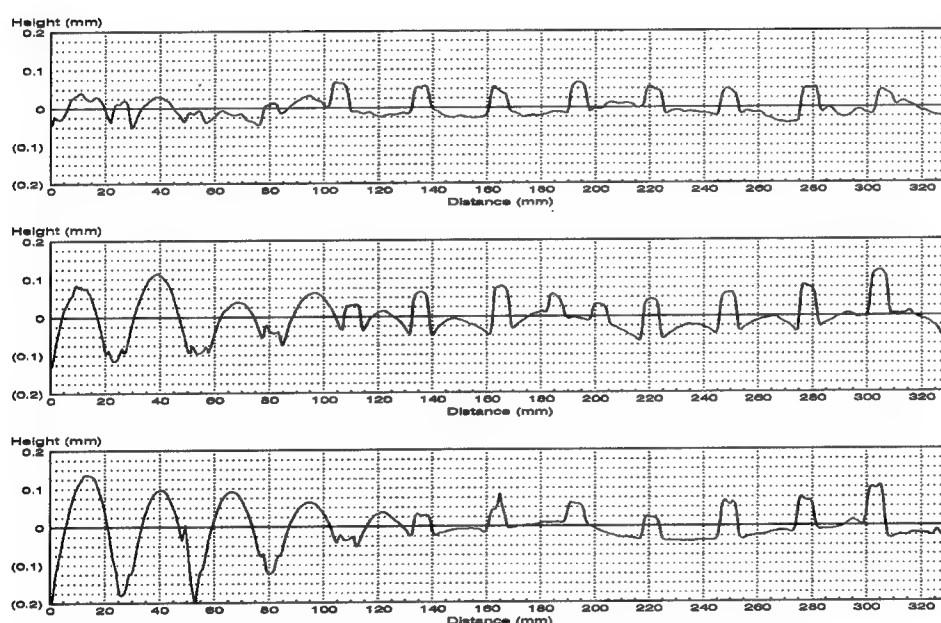
Figure 13: Profiles of the three rivet rows in order from top to bottom

Finally, Figure 13 shows a line-scan image of the sample. Below this, arranged in the same order top to bottom, are dimensional profiles of the three rows of rivets.

The profiles in Figure 13 begin just after the first rivet at the left of each row. The perception of the rivet heads "sinking" into the hills between them is a side effect of subtracting the third order curve. Generally there is a good visual correlation between the height of the bulge between rivets and its DAIS signature. Unfortunately, the largest bulges between the first and second rivets in rows 2 and 3 (0.3 mm and 0.2 mm high respectively) do not have distinct signatures. It is surmised that this is due to their proximity to the sample's edge.

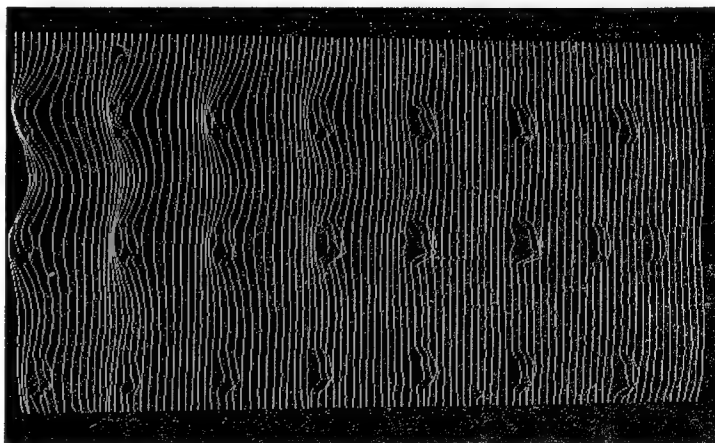
Figure 2: Surface profile of horizontal lap splice

The use of the amount of pillowing or surface height deflection as an indicator of corrosion presence and level is supported by surface traces of corroded and non-corroded areas on actual specimens. Figure 2 shows a two dimensional physical profile of a horizontal lap splice from a B-727. The figure clearly indicates that the surface pillowing or bulging between the rivets on the left side increases to a much higher degree than on the right side or along the bottom row of rivets. Eddy current scans between

the rivet rows indicate that the percent material loss in the areas of increased surface height reaches 25 percent in the top row and up to 15 percent in the second row. Such evidence supports the notion that the physical deformation of the upper surface has a direct relationship

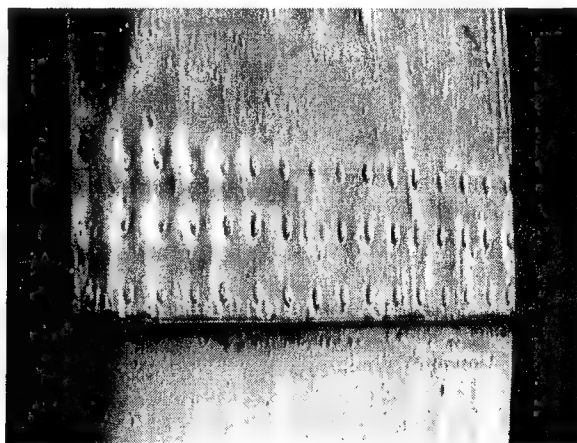
Giving all surfaces a consistent yet temporary reflective finish is best accomplished through highlighting. This is a process whereby a thin liquid film is evenly applied to fill in the surface's microscopic roughness making it reflective without introducing a second liquid surface that may mask the underlying surface variations. For example, Figure 4 shows a DAIS captured view of a section of horizontal lap splice cut from a decommissioned aircraft. From the seam upwards the surface has a white, low gloss paint finish while below the seam the surface is bare aluminum. Although a slight amount of surface deformation is detected around the rivets on the left hand side, the image signatures are very low contrast and ill defined. Overall, the reflectivity of this surface is poor and uneven. Figure 5 illustrates the effect of highlighting this surface. All surface variations, including the "pillowing" around the left most rivets can now be seen clearly as bright white areas.

**Figure 5:** Same lap splice, highlighted

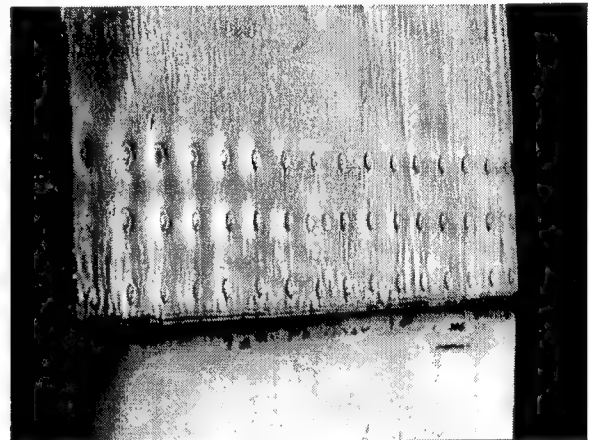
Make sure the entire surface area to be inspected is coated. As seen in Figure 8, dry regions will show as zones of low reflectivity with poor contrast. If too little highlighter is applied to the surface, the resulting images will be less than optimal. As seen in Figure 9, the effect is that pillowing signatures around rivets, although visible, are somewhat subdued in intensity. The result from an application of too much highlighter is dependent on the orientation of the surface. On the horizontal surface shown in Figure 10 the fluid tends to puddle and hide the surface. On the vertical surface in Figure 11 too much highlighter causes runs. In both cases the DAIS sensor is imaging variations in the surface of the fluid film, not the underlying aircraft surface.

**Figure 9:** Application of too little highlighter

If there is too little fluid, add more to the surface directly from the bottle and spread it over the surface. If there is too much fluid, use the applicator to spread the highlighter over a larger area.

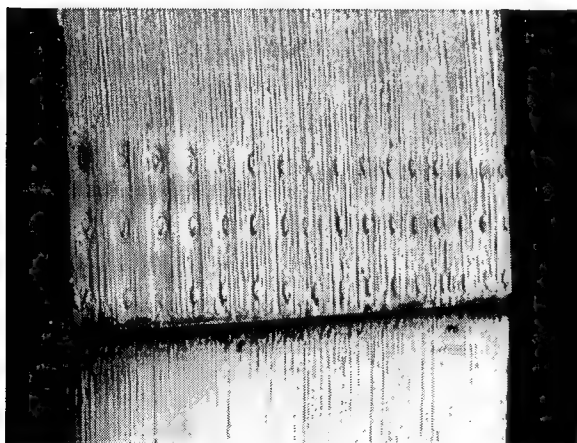
Figure 13. The fluid in both illustrations has been applied with a paper towel to produce streaks far more severe than those produced by the sponge applicator. When the streaks travel across the sensor's field of view, as in Figure 12, they produce a distinct pattern of background noise which can disguise legitimate surface variations. When similar streaks are oriented to run along the sensor's view, as in Figure 13, they are much less objectionable.

**Figure 12:** Highlighter streaks across the sensor's view

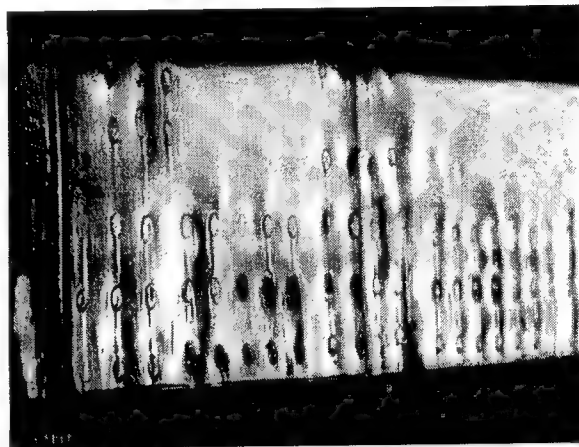
Experience with highlighting vertical surfaces has shown that even with the best possible application of highlighter there will be some unavoidable streaks due to the presence of rivet heads. As shown in Figure 14, even with a careful application the fluid tends to collect and run from some rivet heads, especially those with button heads. These surface runs must be recognized and tolerated during image analysis. Another potential hazard of applying too much highlighter to vertical surfaces is the potential for contaminating the optical components inside the upturned DAIS sensor.

**Figure 14:** Small highlighter runs from rivet heads

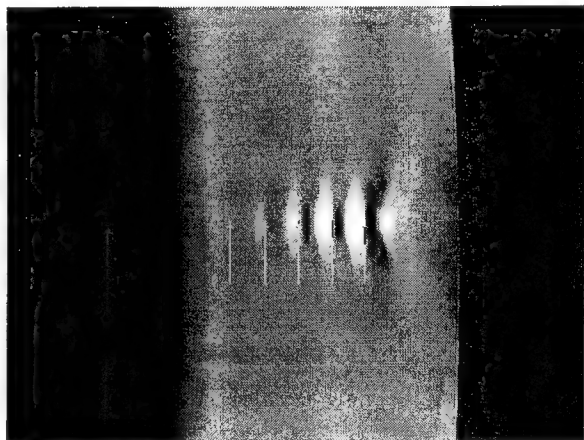
The displacement of the *D SIGHT* signatures to the right of the physical depression can begin to interfere or mix with the signature of the next neighboring depression. When the same set of depressions is imaged along the depression row with the shallow depression on the left as in Figure 17, signature mixing can be observed because the displacement is approximately the same as the depression spacing. Because of this, there may be some ambiguity as to the exact depression creating the signature.

Figure 17: *D SIGHT* signatures when viewed along depression row

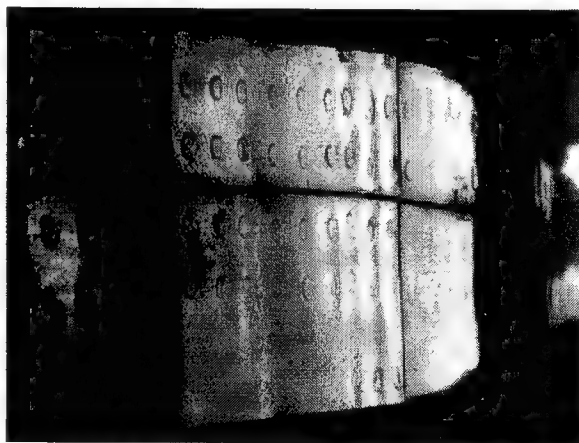
The presence of corrosion in lap splices around rivets causes a physical pillowing or bulging of the surrounding surface while the clamping force of the rivet prevents the surface from bulging to the same extent in the vicinity of the rivet. As a result, the rivet area forms a local depression in the surface. The key *D SIGHT* signature that indicates the presence of this depression at a moderate to high corrosion level is the occurrence of a dark-to-bright gray scale variation to the immediate right of the rivet with a bright zone immediately to the left of the rivet. Figure 18 shows these signatures for the specimen that was physically profiled in Figure 2. The dark and bright area to the right of the rivet corresponds to the physical indication of a depression while the bright zone to the left of the rivet indicates a severe depression (corrosion). The greater the contrast in this signature (ie. greater bright-dark-to-bright gray scale disparity), the greater is the physical depression. Corrosion severity increases with increased signature contrast. Notice that signature contrast increases over four rivets from right to left in the top row as the corrosion level increases. Similar signatures are found on circumferential butt splices even though the underlying surface is cylindrical in shape as shown in Figure 19.

Figure 19: Circumferential lap splice corrosion

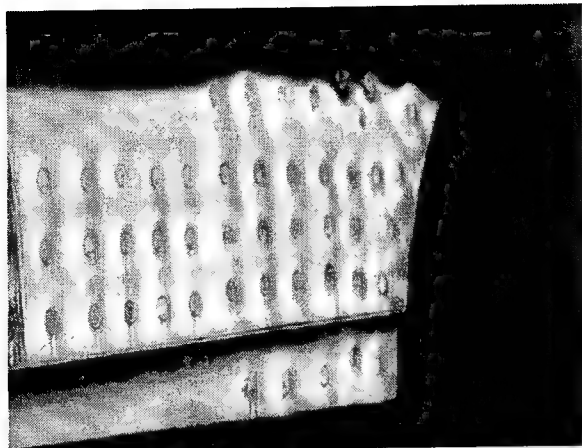
**Figure 20:** Weak signatures of corrosion

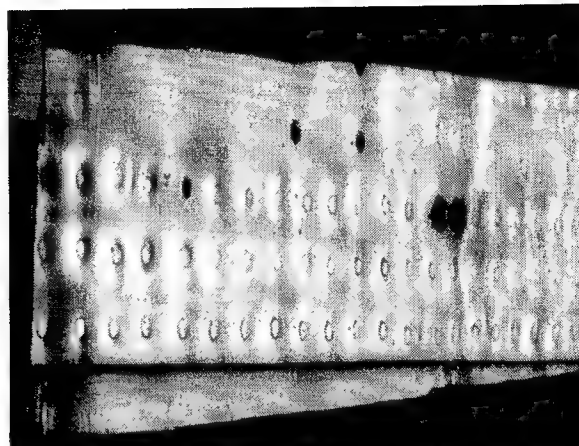
**Figure 21:** Lap splice corrosion on bare aluminum

Figure 21 is an example of a bare aluminum lap splice with corrosion predominately on the left side. The center row of rivets exhibit strong signature indications of corrosion. The edges of some rivets appear recessed to a point that they are no longer visible in the image. Such a condition is another key signature feature of corrosion. The fourth rivet from the left hand side of the middle row is recessed so deeply that the dark part of the signature is in fact in line with the rivet. Note that the fifth rivet from the left hand side in the top row is missing altogether.

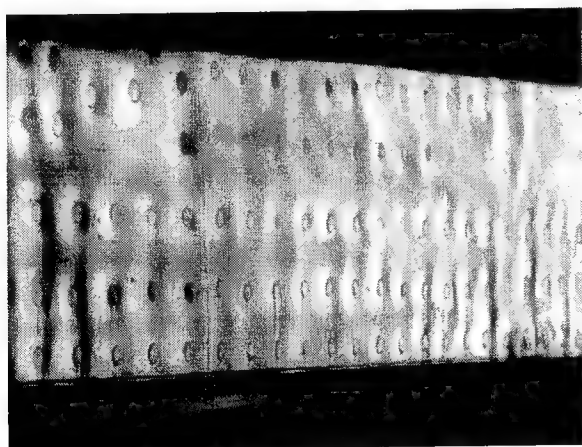
**Figure 22:** Two types of corrosion signatures

Figure 22 and Figure 23 are two more examples of lap splice corrosion. Figure 22 shows both types of corrosion signatures; bright areas around rivets to the right and wave signatures on the left. Figure 23 has no corrosion on the left side with two columns of rivets exhibiting corrosion followed by an area with significant corrosion signatures. The extreme right side of the image also indicates signatures of corrosion.

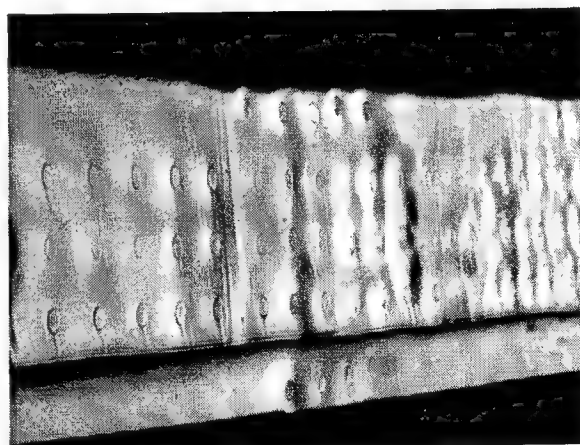
**Figure 23:** Severe corrosion signatures and uncorroded area

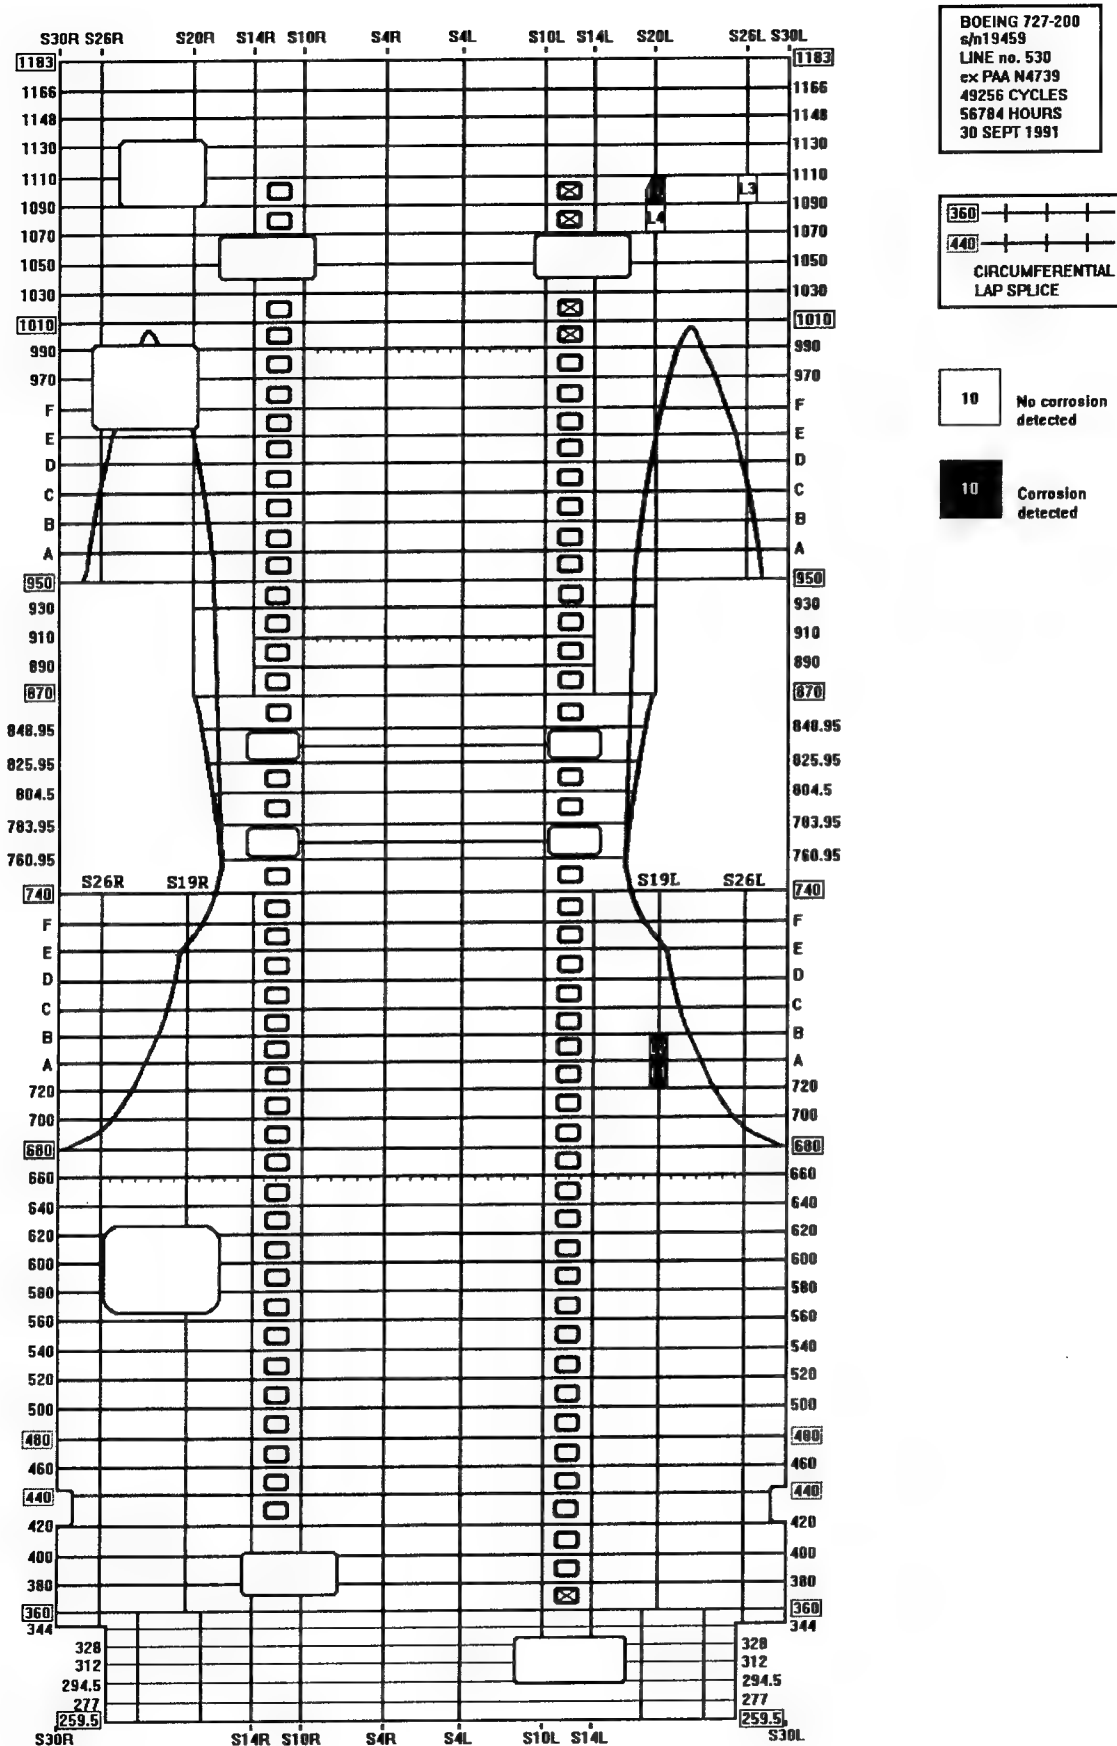
Figure 5.4 B727-N4739 specimens. Results of D Sight inspection for corrosion.

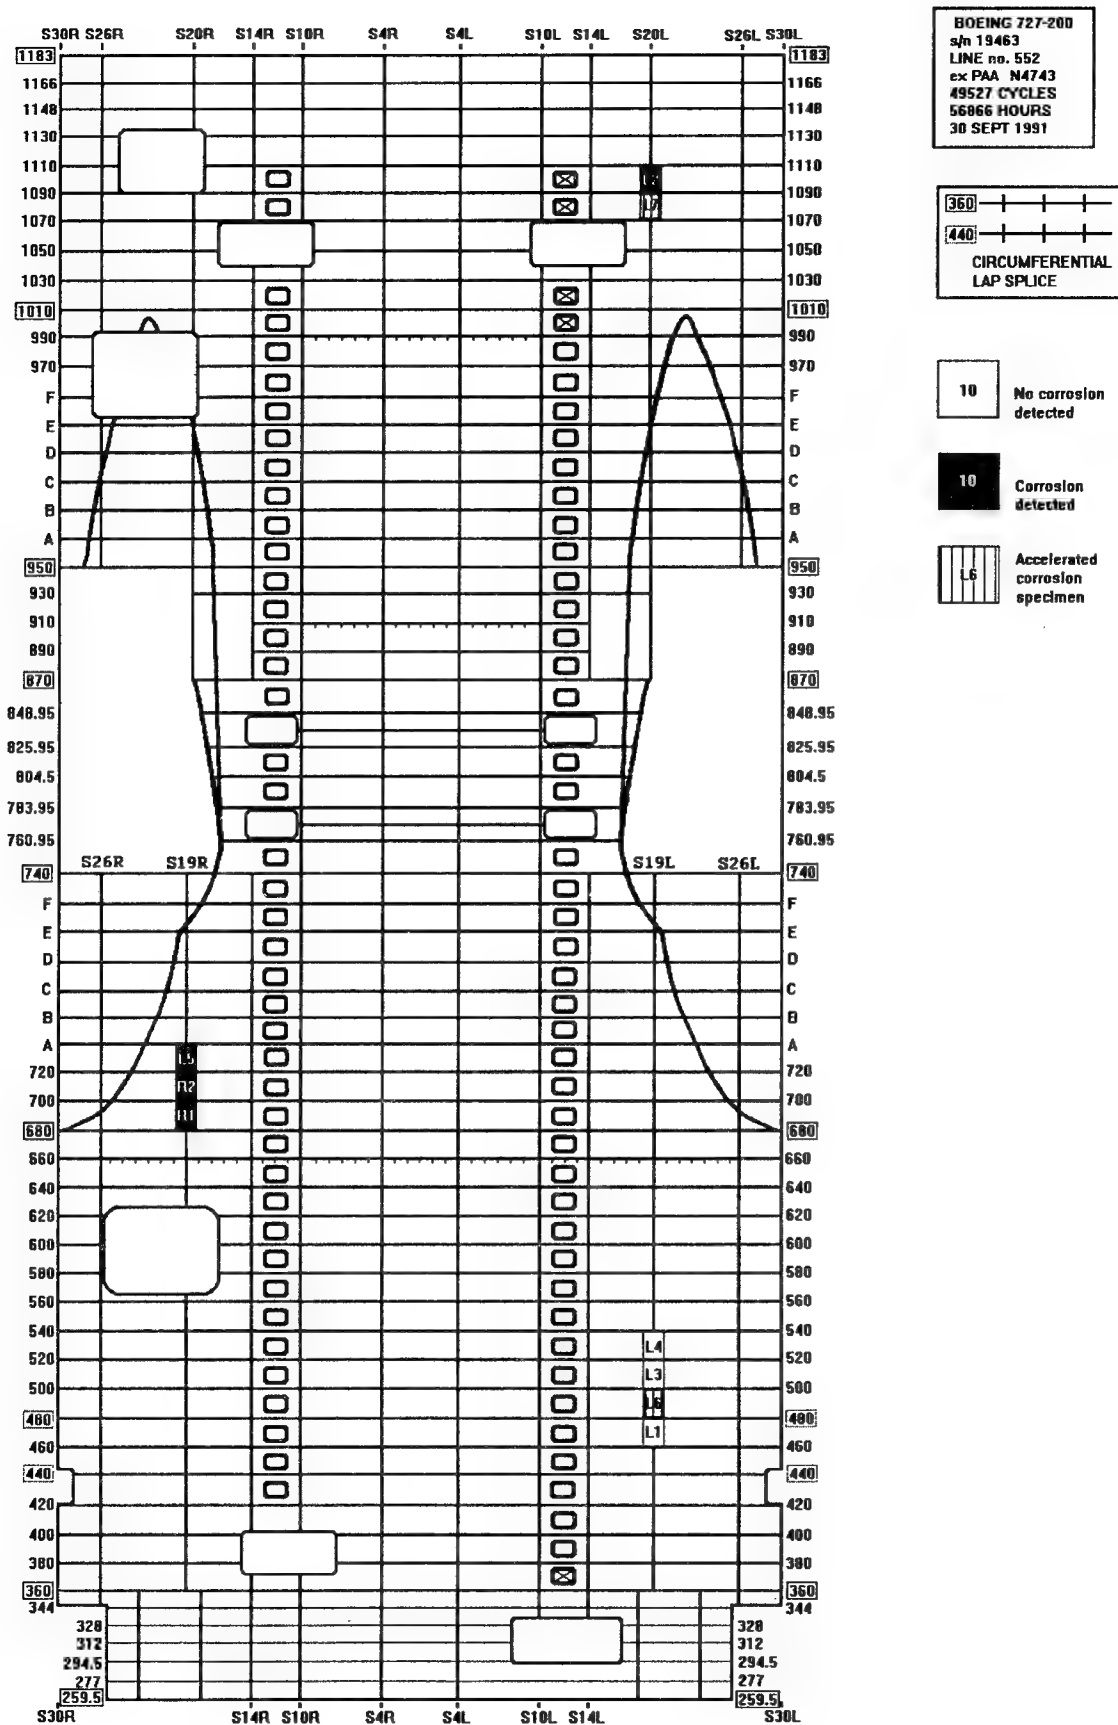
Specimen Number	Image Number	D Sight Image Comment and (construction of the joint)
L1		
L2		top and bottom row
L3		
L4		
L5		top and middle row
L6		
L7		[accelerated corrosion specimen]
R1		(at Diffracto)
R2		top and middle row

Figure 5.5 B727-N4743 specimens. Results of D Sight inspection for corrosion.

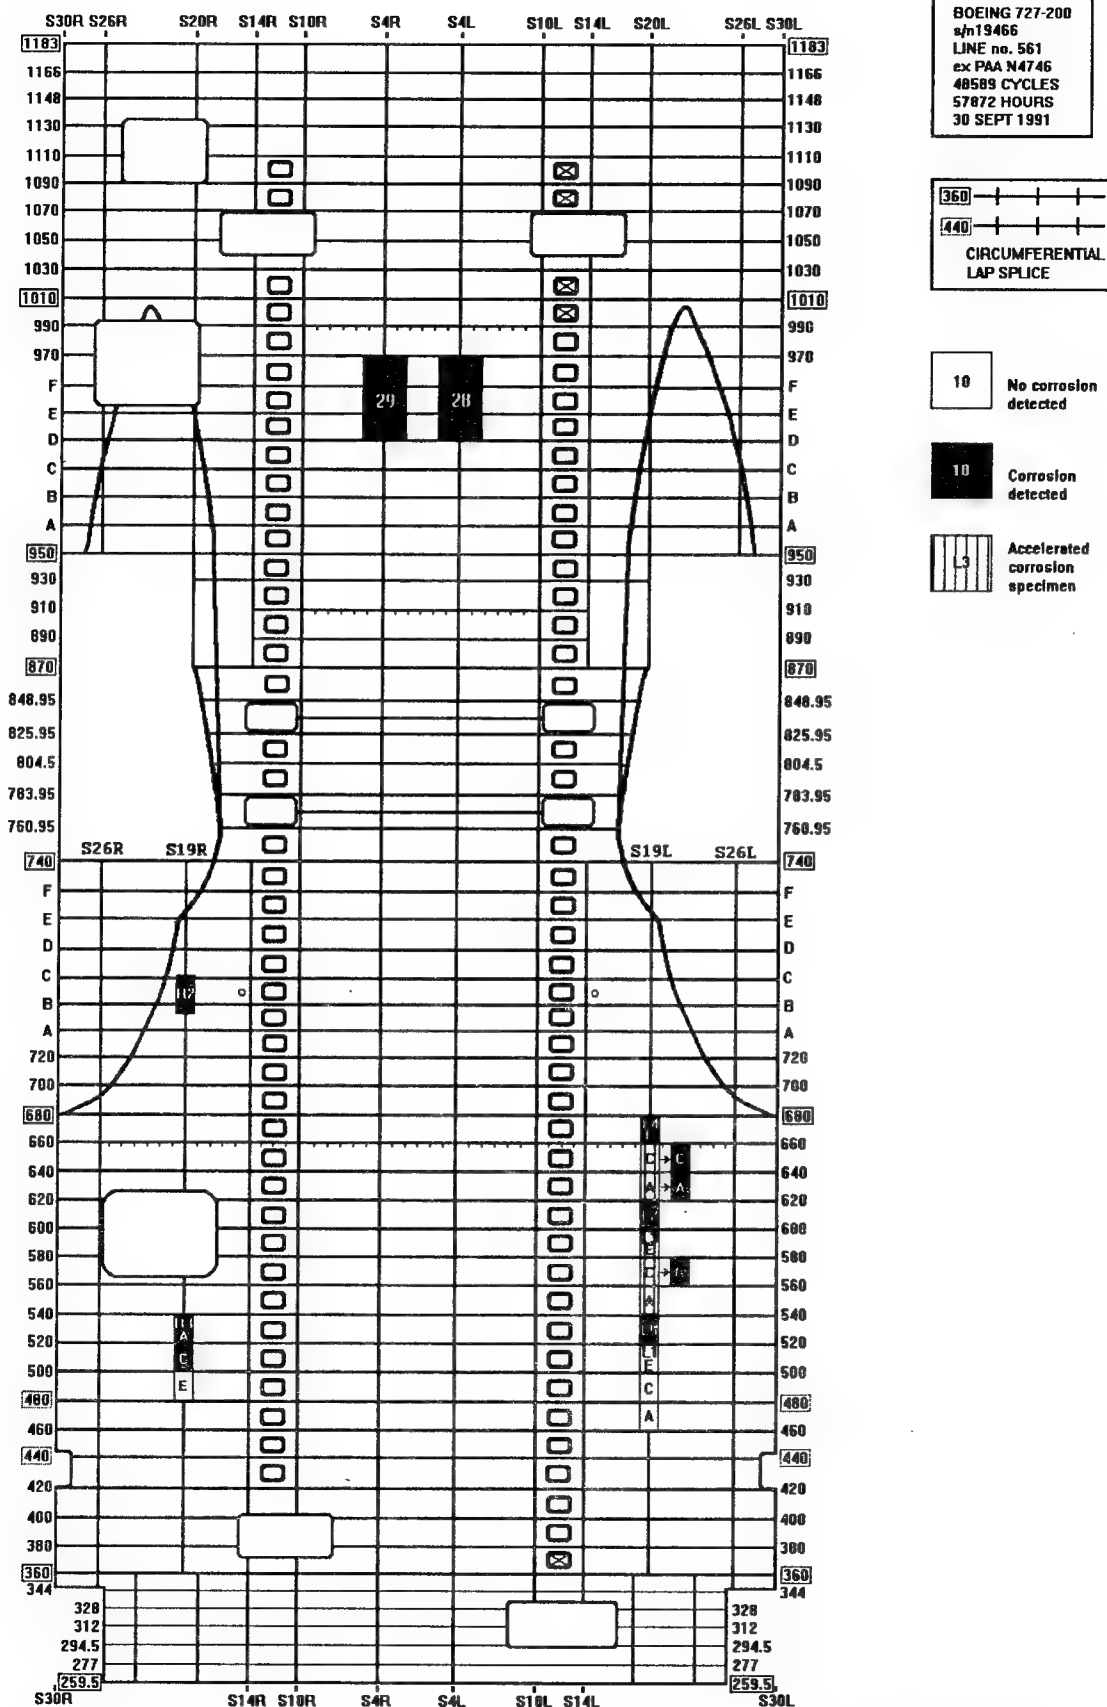
<b>Specimen Number</b>	<b>Image Number</b>	<b>D Sight Image Comment and (construction of the joint)</b>
L1A		
L1C		
L1E		five rivets top to bottom from left edge
L2		six rivets top to bottom middle of the specimen
L3A		
L3C		bottom row of rivets
L3E		middle row slight indication
L4A		two rivets bottom row from left specimen edge
L4C		some rivets in the top row
L4E		(teardown)(accelerated corrosion specimen)
L5		slight pillowing middle row right side three rivets
L6		
R3A		pillowing middle row
R3C		middle and top row
R3E

Figure 5.6 B727-N4746 specimens. Results of D Sight inspection for corrosion.
